25th January 2018**To: Masters, officers and engineers.****NARRATIVE**

EXPERIENCE SHARE 01-2018	Revision: 0
ME Failure	Issued: 01.01.2017

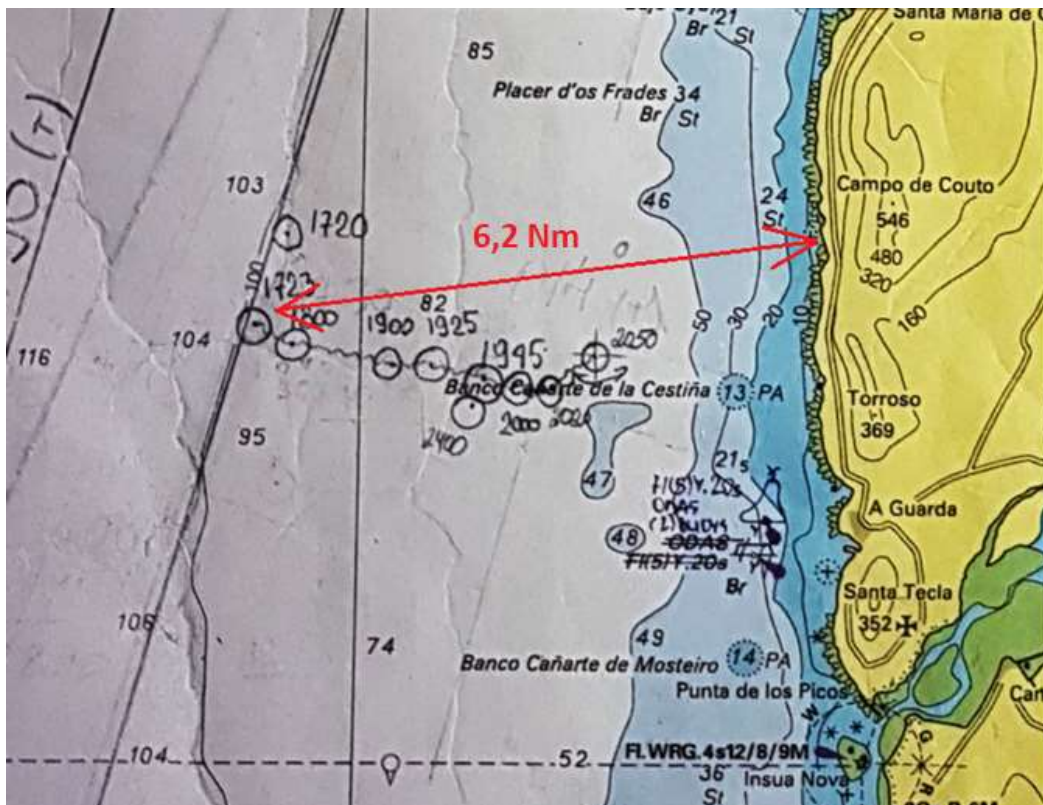
At 17:17 LT, the ME slowdown because safety system has been activated by high water outlet temperature. A duty officer on the bridge received telephone call from a duty engineer to reduce ME RPM immediately. Shortly later, the ME was stopped and the vessel started drifting, however still was proceeding through the water to the SSW. The master was informed when the vessel was stopped. The distance to the nearest Spanish coast was around 6,2 nautical miles. The weather was good with wind – SSW 4 and Sea – SSW 3.

Several minutes after stoppage, the master was informed by engineers about its reason – cracked cooling jacket in ME unit no 5. Knowing that repairs will take at least 4 hours, it has been decided to immobilize the ME, and start dismantling unit no 5 in order to replace the broken cooling jacket.

- ME malfunction due to broken upper cooling jacket in cylinder no.5. At this stage and without specialized expertise, it is hard to determine what was the cause of the cooling jacket damage (material defect or excessive wear and tear).
